Green Audit Report (Environment, Electrical, Energy & Fire Safety) Campus-3

Kalinga Institute of Social Sciences
Deemed to be University

**ENER VISION
(ISO 9001 CERTIFIED & BEE
empaneled ESCO)
Kandivali EAST, MUMBAI**

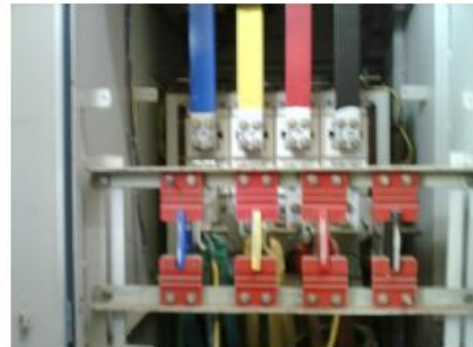
Main incomer panel: -

| Measurement Objects | Temp. [°C] | Emiss. | Refl. temp. [°C] | Remarks |
| Hot spot 1 | 40.4 | 0.92 | 25.0 | temperature found in R phase |
| Hot spot 2 | 43.0 | 0.92 | 25.0 | temperature found in Y phase |
| Hot spot 3 | 41.7 | 0.92 | 25.0 | temperature found in B phase |

| Sl No | Description | Observation / Recommendations |
|---|--|--|
| 4. | HOT Spot test of Power Distribution system | Entire distributions systems are thermal scanned by TESTO German make, calibrated Thermal Imager. Few cable termination the temperature was noticed 50 to 60 Deg C. These are serviced and thermal scanned once again. Temp after service is below 40 Deg C. |
