Green Audit Report (Environment, Electrical, Energy & Fire Safety) Campus-3

Kalinga Institute of Social Sciences
Deemed to be University

**ENER VISION
(ISO 9001 CERTIFIED & BEE
empaneled ESCO)
Kandivali EAST, MUMBAI**

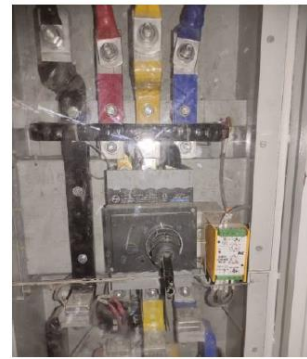
LT Panel Main incomer:

Measurement Objects	Temp. [°C]	Emiss.	Refl. temp. [°C]	Remarks
Hot spot 1	39.1	0.93	19.0	Temperature recorded at R-phase
Hot spot 2	31.7	0.93	19.0	Temperature recorded at Y-phase
Hot spot 3	32.3	0.93	19.0	Temperature recorded at B-phase

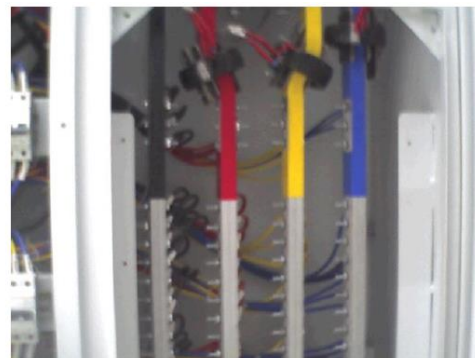
Bus-Bar Chamber:

Measurement Objects	Temp. [°C]	Emiss.	Refl. temp. [°C]	Remarks
Hot spot 1	30.7	0.93	19.0	Maximum Temperature area

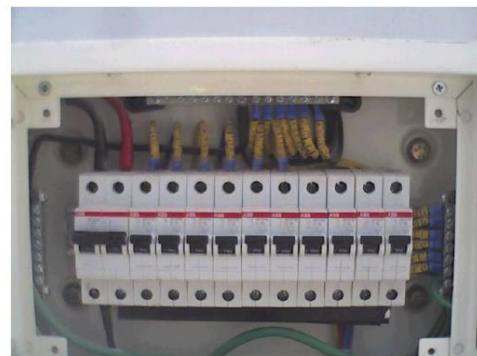
UPS DB:

Measurement Objects	Temp. [°C]	Emiss.	Refl. temp. [°C]	Remarks
Hot spot 1	28.7	0.93	19.0	Temperature recorded at MCB terminations
