Green Audit Report (Environment, Electrical, Energy & Fire Safety) Campus-3

Kalinga Institute of Social Sciences
Deemed to be University

**ENER VISION
(ISO 9001 CERTIFIED & BEE
empaneled ESCO)
Kandivali EAST, MUMBAI**

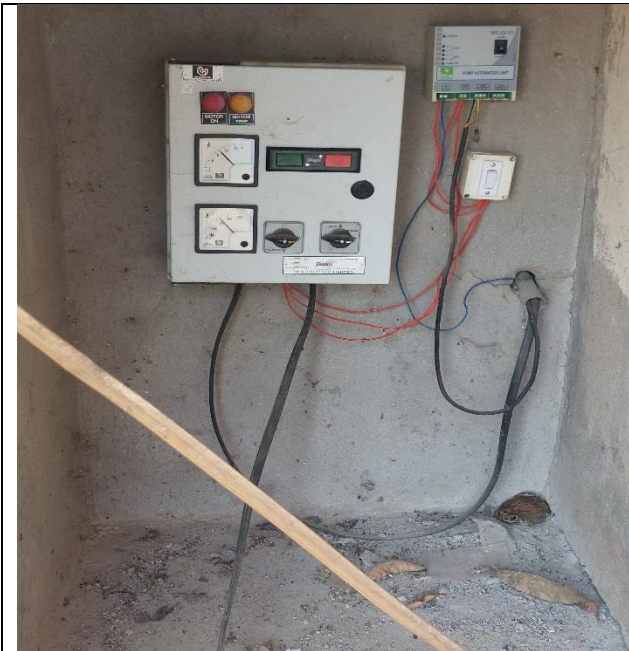
Level sensor of pump with starter

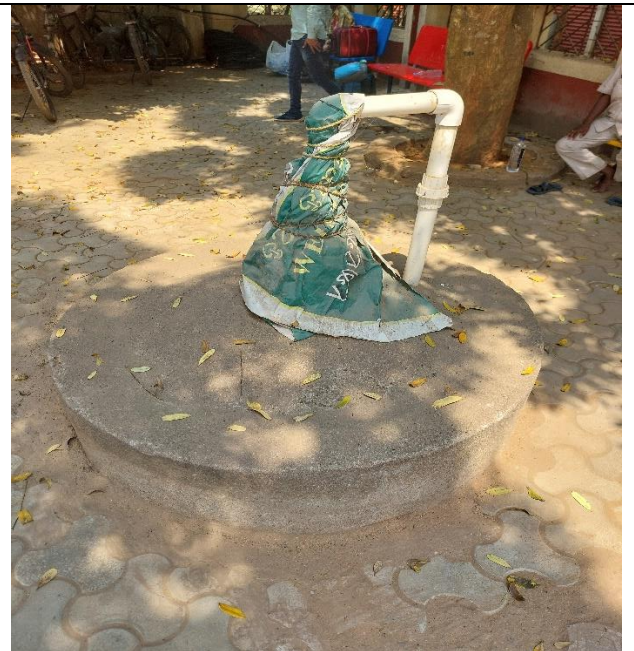
Ground water pump

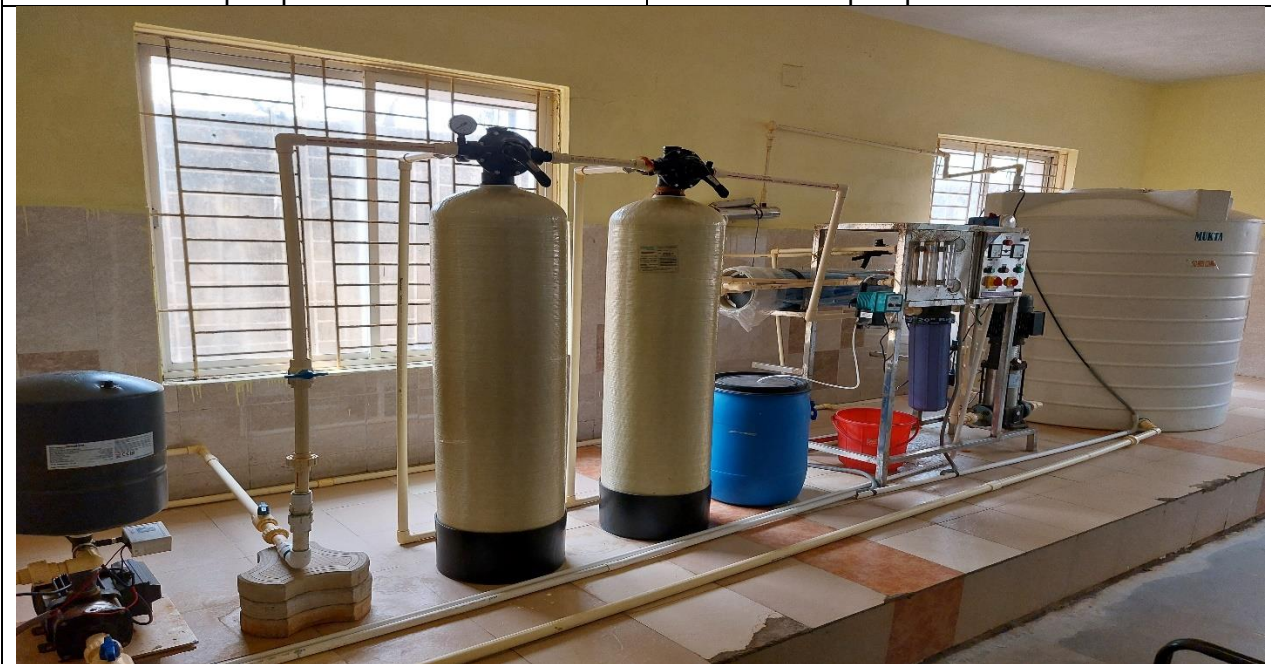
RO Plant

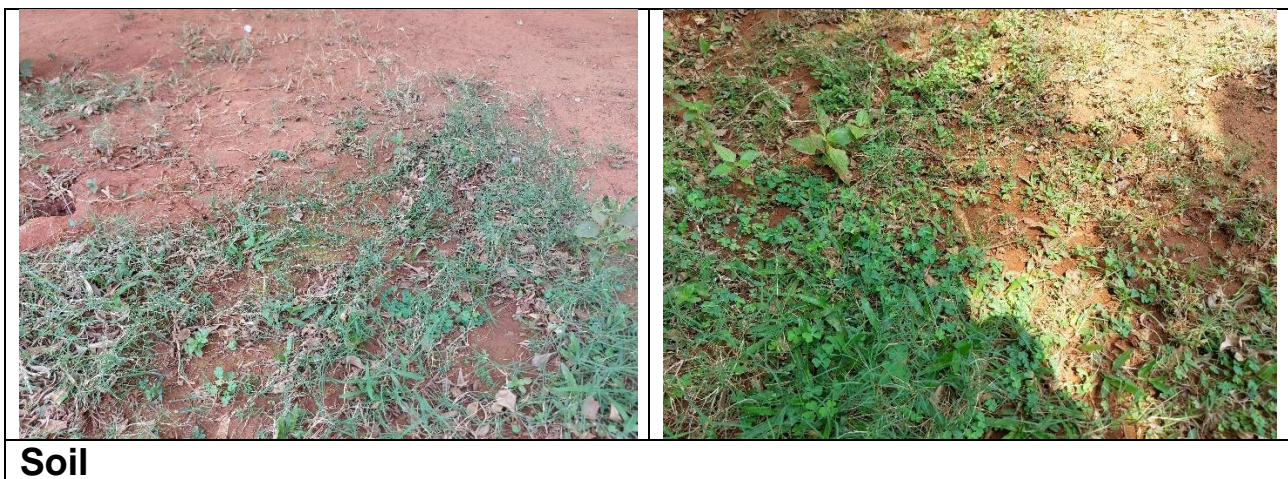
Soil samples were collected from the campus and analyzed for the basic parameters. The results are tabulated and presented in the table:

Parameter	Values
pH	7.1 to 7.3
Total Nitrogen (mg/kg)	2.5 to 2.8
Total organic carbon (%)	1.2 to 1.4
Phosphate (mg/kg)	0.21

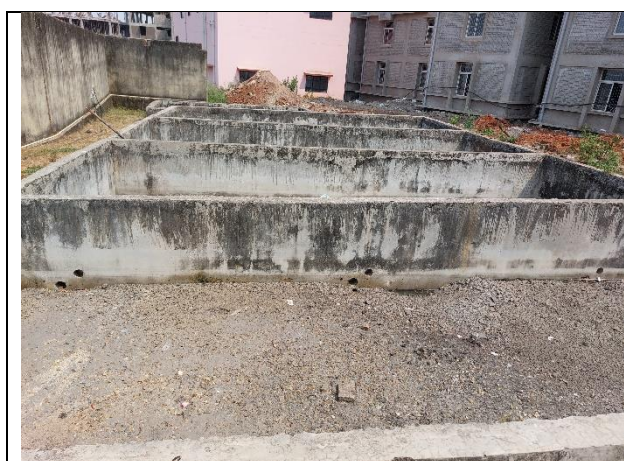
STP

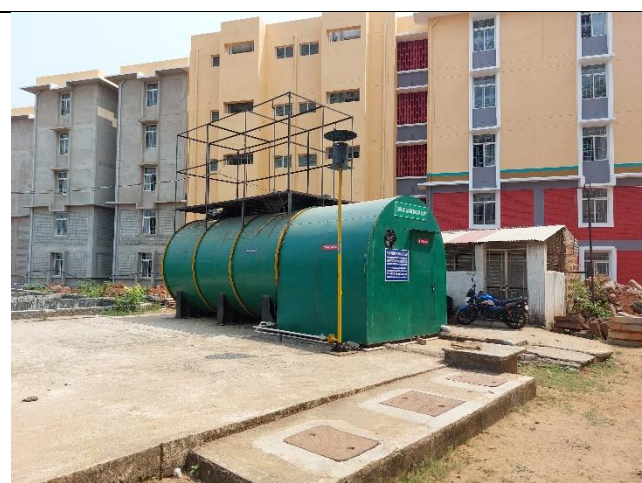
Bio gas plant

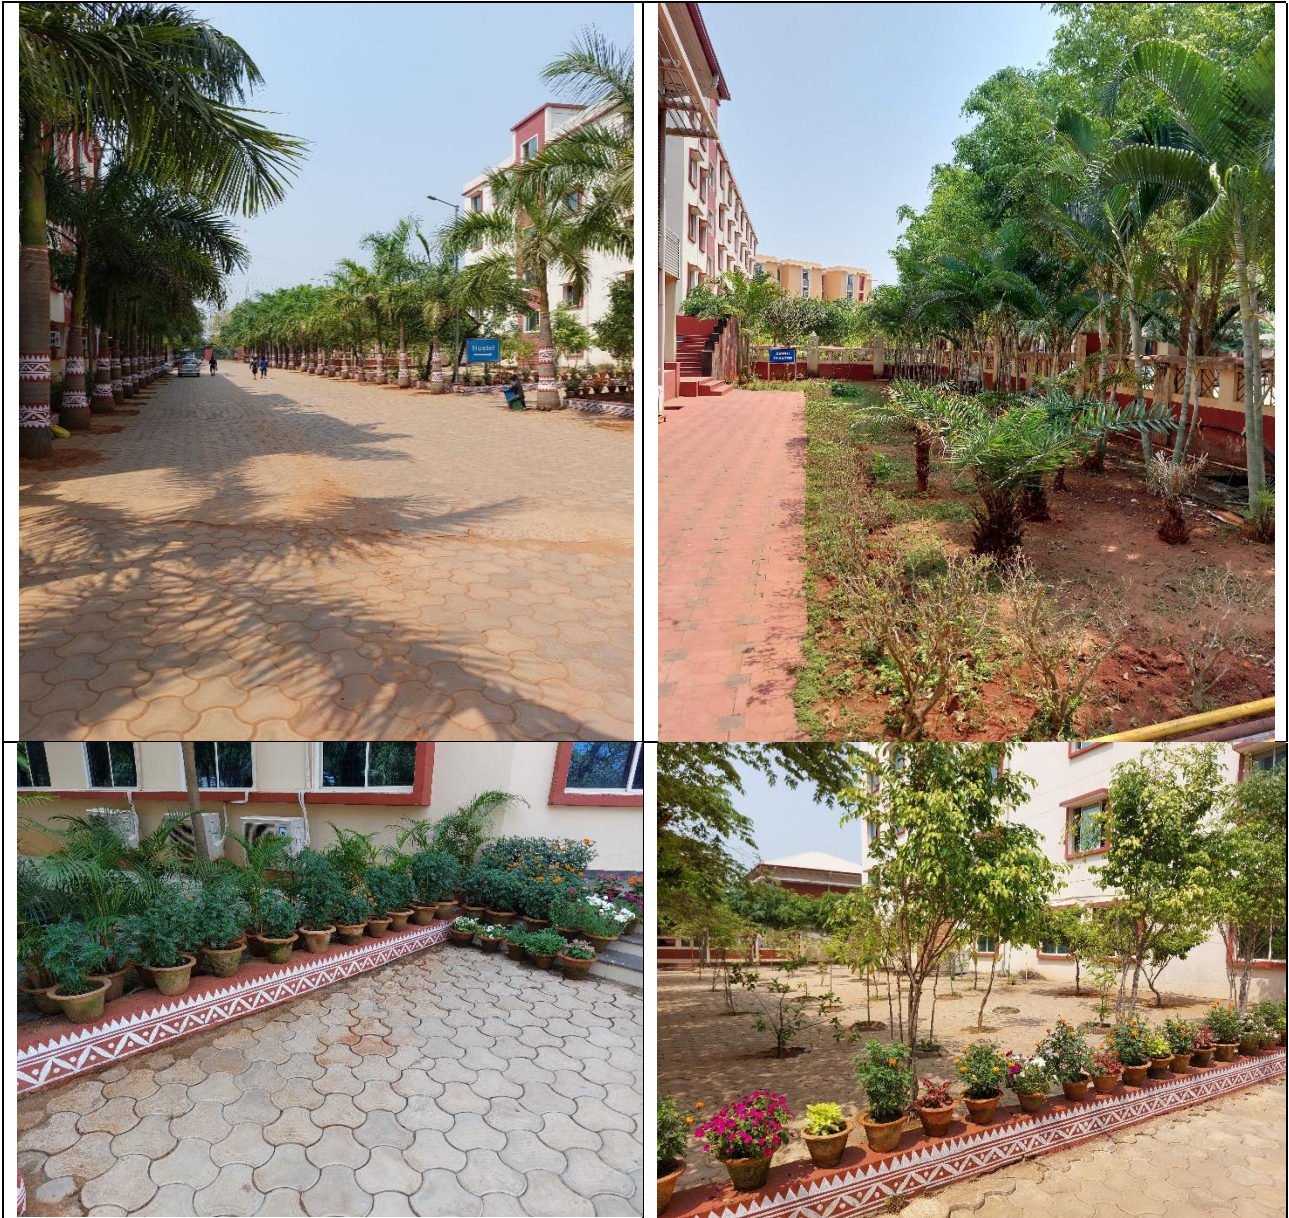
GREENERY/PLANTATION

Great work has been initiated in the last year of planting so many trees. The greenery inside the campus is good and fresh air is flowing all over the campus. Use of day light in the building of the campus is very good.

In order to increase the carbon credit and greenery of the campus, it is recommended to plant more indigenous and evergreen / fruit trees inside the campus. Day light using in the campus is very good. Especially in the academic building the day light is very good.

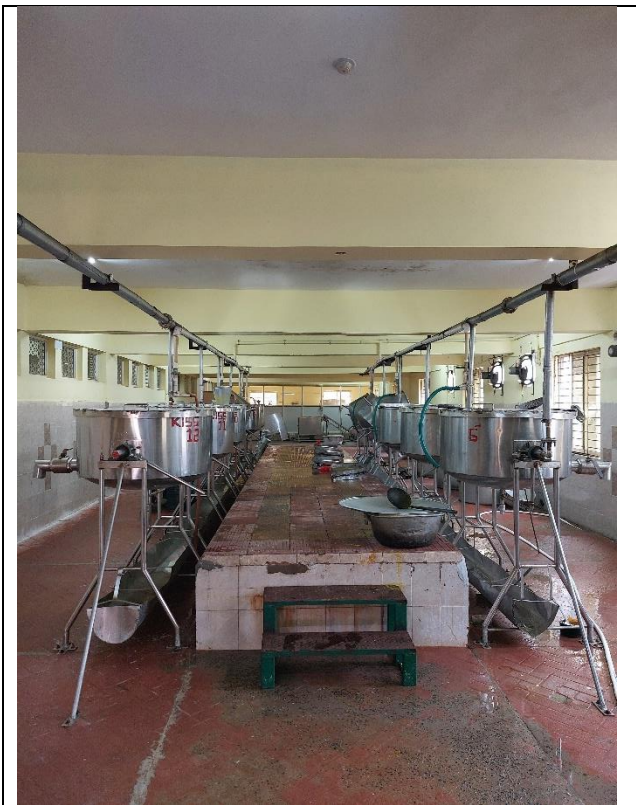
Steam based cooking system

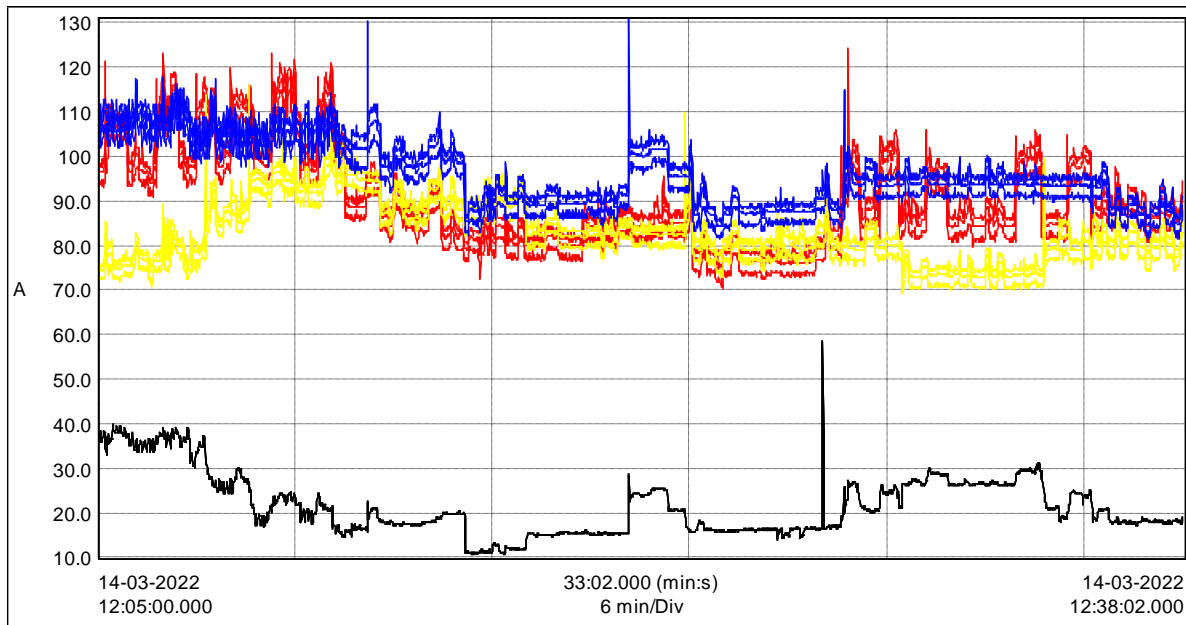
A_{rms} –

Name	Date	Time	Avg	Min	Max	Units	Duration	Units
A1 rms	14-03-2022	12:05 PM	90.92	70.50	124.50	A	33:03.000	(min:s)
A2 rms	14-03-2022	12:05 PM	83.31	69.50	116.00	A	33:03.000	(min:s)
A3 rms	14-03-2022	12:05 PM	96.47	81.50	134.50	A	33:03.000	(min:s)
AN rms	14-03-2022	12:05 PM	22.79	10.90	58.50	A	33:03.000	(min:s)

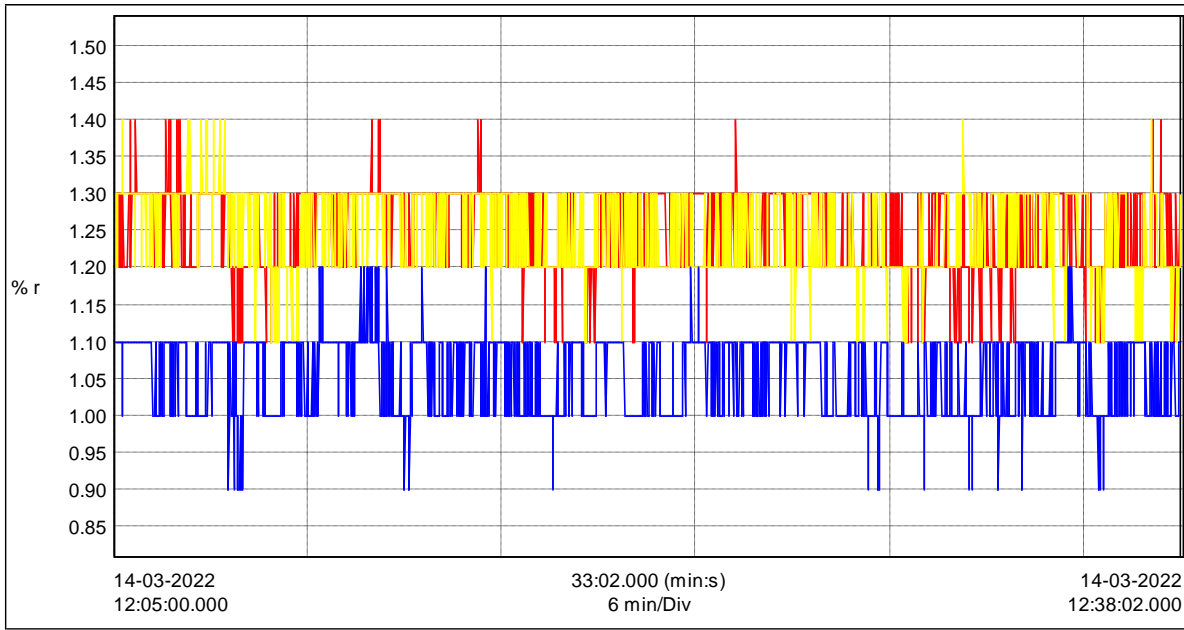
VThdr:

Name	Date	Time	Avg	Min	Max	Units	Duration	Units
V1 THDr	14-03-2022	12:05 PM	1.251	1.1	1.4	% r	33:03.000	(min:s)
V2 THDr	14-03-2022	12:05 PM	1.247	1.1	1.4	% r	33:03.000	(min:s)
V3 THDr	14-03-2022	12:05 PM	1.054	0.9	1.2	% r	33:03.000	(min:s)
VNE THDr	14-03-2022	12:38 PM	---	NA	NA	% r	1.000	(s)

Remarks: Voltage harmonic values are normal and are within the limit.

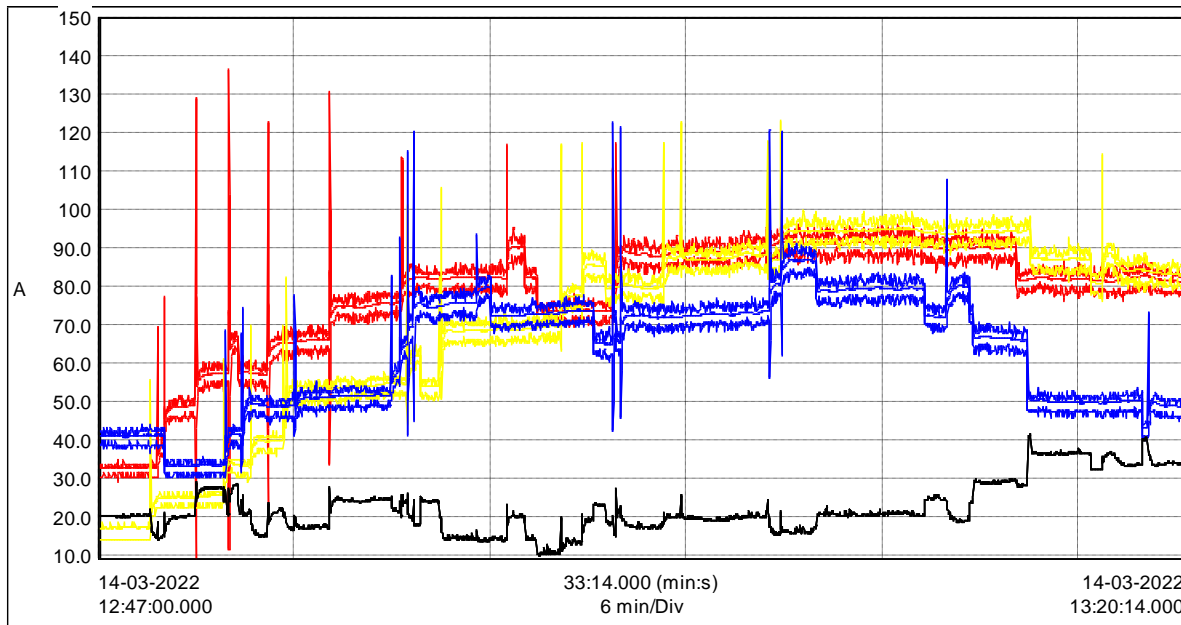
A_{rms} –

Name	Date	Time	Avg	Min	Max	Units	Duration	Units
A1 rms	14-03-2022	12:47 PM	79.45	0.00	136.50	A	33:15.000	(min:s)
A2 rms	14-03-2022	12:47 PM	75.07	14.50	123.50	A	33:15.000	(min:s)
A3 rms	14-03-2022	12:47 PM	64.61	30.50	123.00	A	33:15.000	(min:s)
AN rms	14-03-2022	12:47 PM	23.54	10.40	42.00	A	33:15.000	(min:s)

Remarks – The up's and down's in the current trend in each phase represents that the AC machines compressor are switching ON & OFF. This is a good sign.

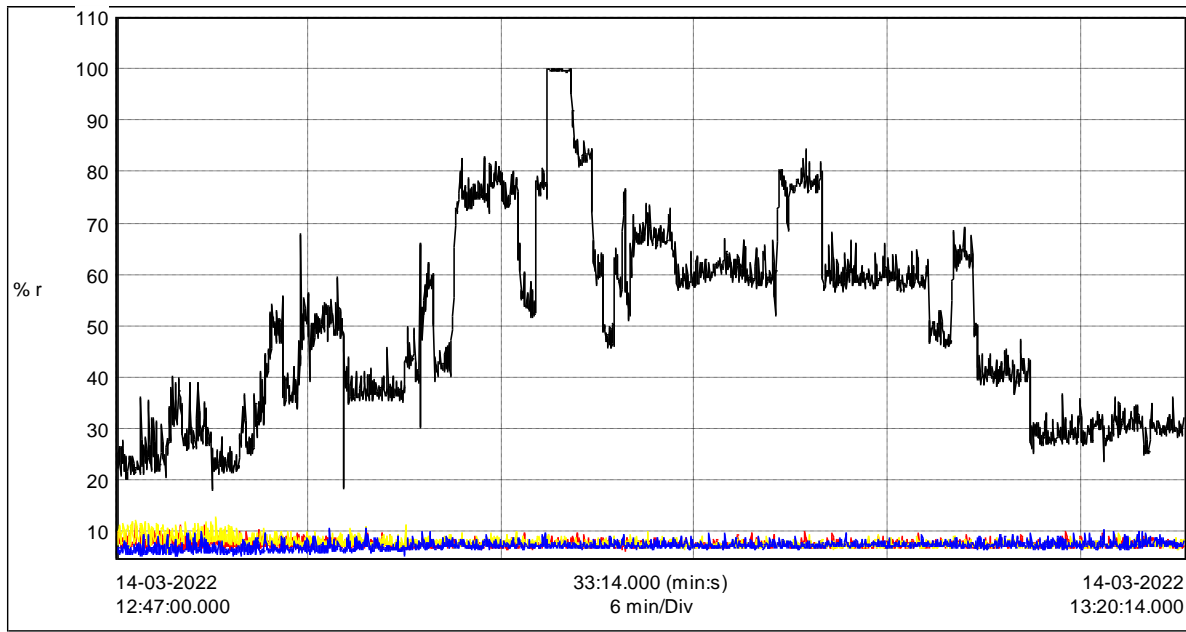
AThdr:

Name	Date	Time	Avg	Min	Max	Units	Duration	Units
A1 THDr	14-03-2022	12:47 PM	7.71	6.4	11.6	% r	33:15.000	(min:s)
A2 THDr	14-03-2022	12:47 PM	7.97	6.1	12.8	% r	33:15.000	(min:s)
A3 THDr	14-03-2022	12:47 PM	7.432	5.4	10.8	% r	33:15.000	(min:s)
AN THDr	14-03-2022	12:47 PM	50.676	18.2	100	% r	33:15.000	(min:s)

Remarks: Current harmonic values are low

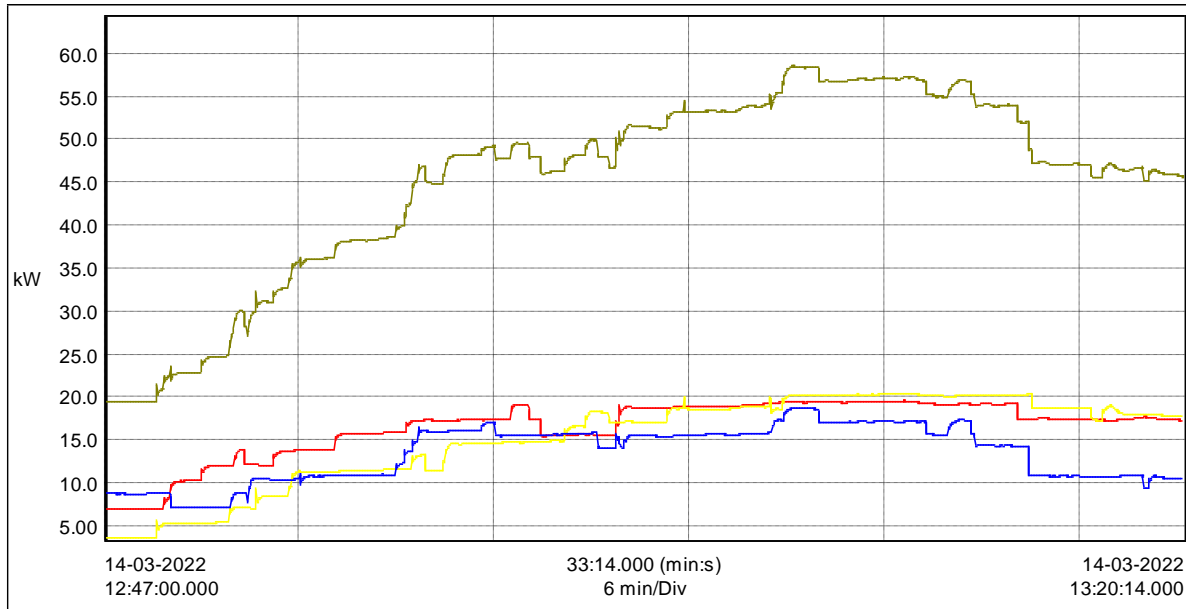
Power (KW):

Name	Date	Time	Avg	Min	Max	Units	Duration	Units
P1 (W)	14-03-2022	12:47 PM	16.527	6.967	19.627	W	33:15.000	(min:s)
P2 (W)	14-03-2022	12:47 PM	15.219	3.691	20.459	W	33:15.000	(min:s)
P3 (W)	14-03-2022	12:47 PM	13.498	7.176	18.791	W	33:15.000	(min:s)
PT (W)	14-03-2022	12:47 PM	45.243	19.458	58.571	W	33:15.000	(min:s)

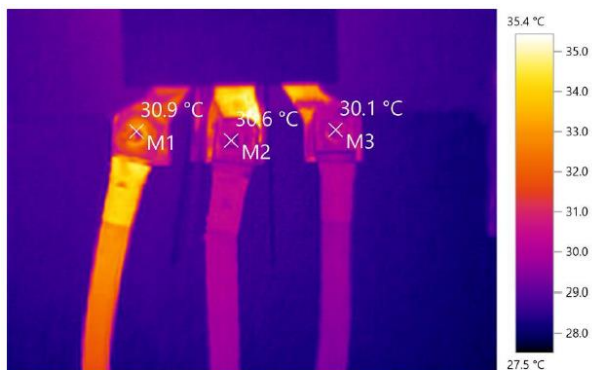
Panel main incomer:

Picture data:	Date:	09-03-2022	Emissivity:	0.93
	Time:	15:48:46	Refl. temp. [°C]:	19.0
	File:	IV_16269.BMT

Measurement Objects	Temp. [°C]	Emiss.	Refl. temp. [°C]	Remarks
Measure point 1	30.9	0.93	19.0	Temperature recorded at R-phase
Measure point 2	30.6	0.93	19.0	Temperature recorded at Y-phase
Measure point 3	30.1	0.93	19.0	Temperature recorded at B-phase

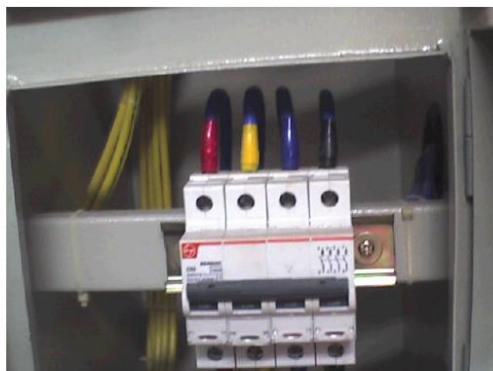
Outgoing feeders:

Picture data:	Date:	09-03-2022	Emissivity:	0.93
	Time:	15:50:56	Refl. temp. [°C]:	19.0
	File:	IV_16278.BMT

Measurement Objects	Temp. [°C]	Emiss.	Refl. temp. [°C]	Remarks
Hot spot 1	34.3	0.93	19.0	Temperature recorded at lugs

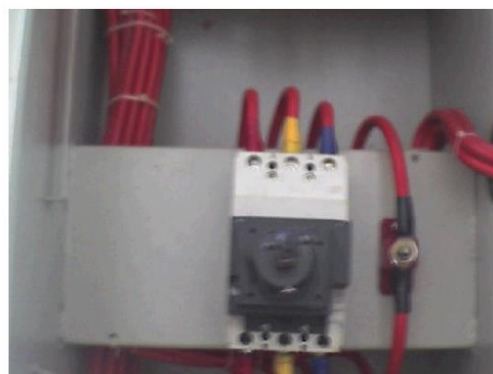
AC DB feeder:

Picture data:	Date:	09-03-2022	Emissivity:	0.93
	Time:	16:04:29	Refl. temp. [°C]:	19.0
	File:	IV_16293.BMT

Measurement Objects	Temp. [°C]	Emiss.	Refl. temp. [°C]	Remarks
Hot spot 1	35.6	0.93	19.0	Temperature recorded at lugs

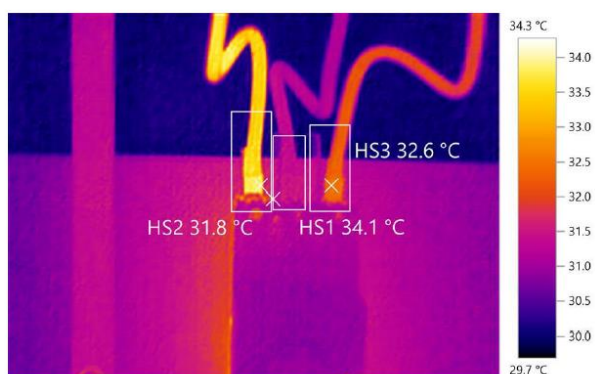
AC sub panel incomer:

Picture data:	Date:	09-03-2022	Emissivity:	0.93
	Time:	16:36:46	Refl. temp. [°C]:	19.0
	File:	IV_16317.BMT

Measurement Objects	Temp. [°C]	Emiss.	Refl. temp. [°C]	Remarks
Hot spot 1	34.1	0.93	19.0	Temperature recorded at R-phase
Hot spot 2	31.8	0.93	19.0	Temperature recorded at Y-phases
Hot spot 3	32.6	0.93	19.0	Temperature recorded at B-phase

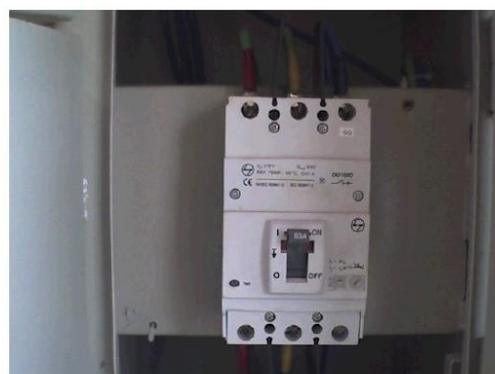
Lighting sub panel incomer:

Picture data:	Date:	09-03-2022	Emissivity:	0.93
	Time:	16:38:47	Refl. temp. [°C]:	19.0
	File:	IV_16322.BMT

Measurement Objects	Temp. [°C]	Emiss.	Refl. temp. [°C]	Remarks
Hot spot 1	34.7	0.93	19.0	Temperature recorded at R-phase

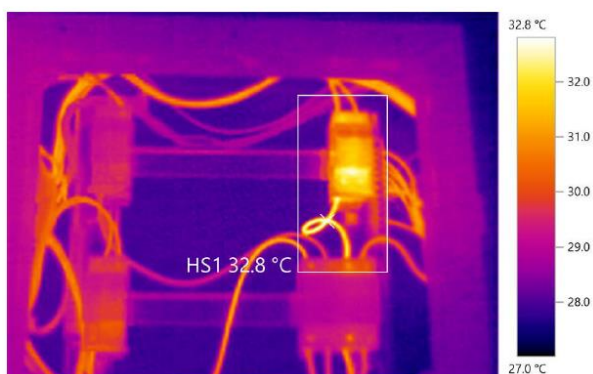
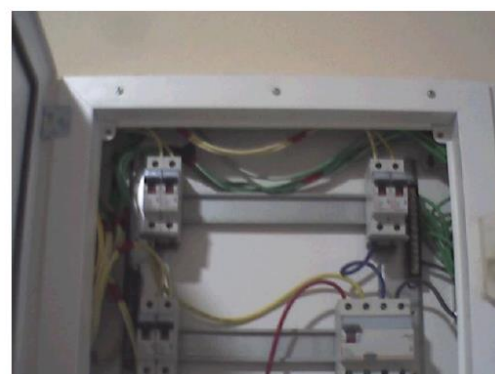
1st floor DB:

Picture data:	Date:	09-03-2022	Emissivity:	0.93
	Time:	16:43:06	Refl. temp. [°C]:	19.0
	File:	IV_16327.BMT

Measurement Objects	Temp. [°C]	Emiss.	Refl. temp. [°C]	Remarks
Hot spot 1	32.8	0.93	19.0	Temperature recorded at B-phase wire & MCB

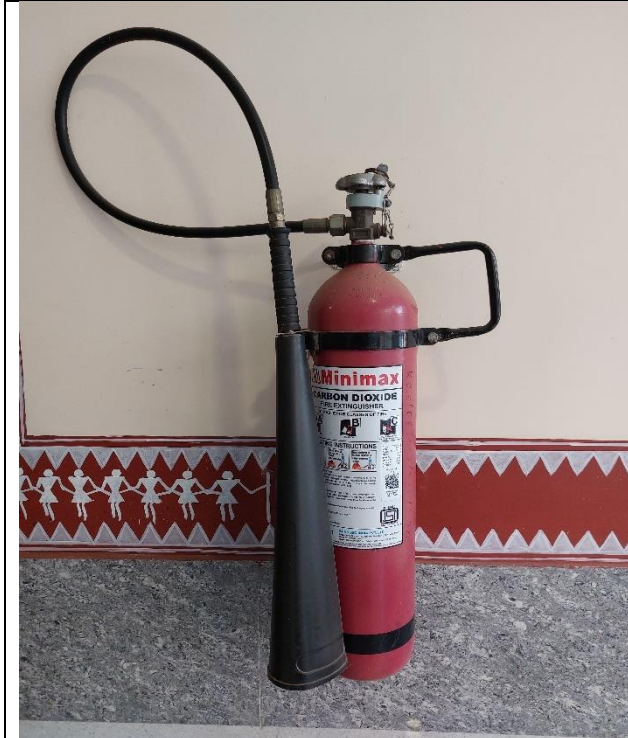
Co2 type fire extinguisher

Signages are missing and this needed to be done.

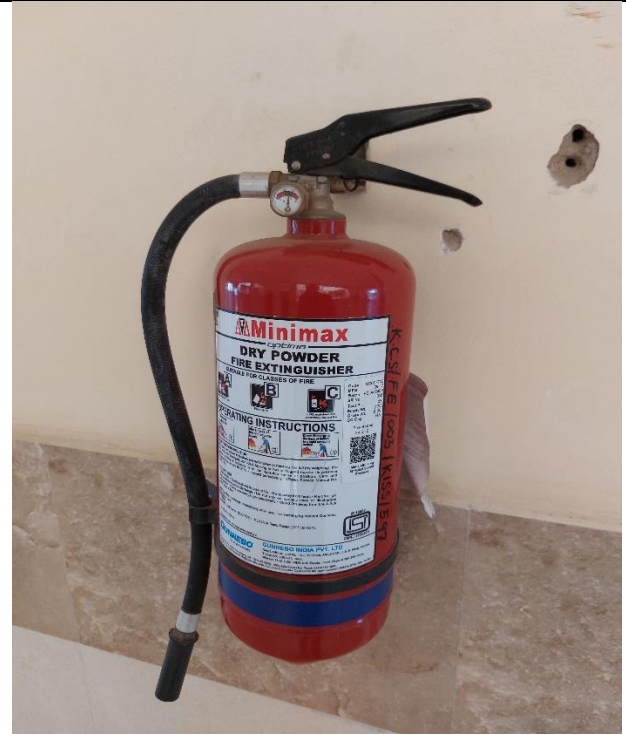
ABC Dry powder type fire extinguisher
