2020-2021

Green Audit Report (Environment, Electrical, Energy & Fire Safety) Campus-3

Kalinga Institute of Social Sciences Deemed to be University

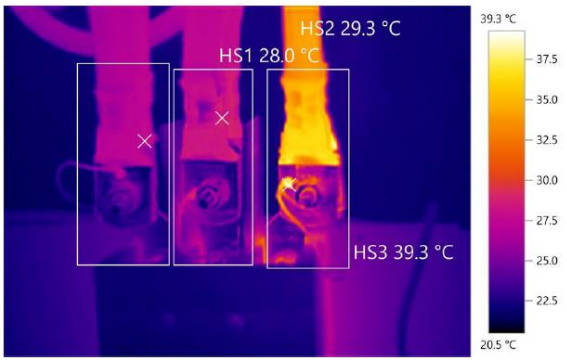
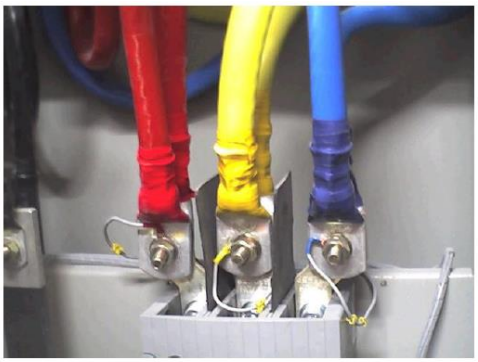
LT Panel Main Incomer:

Measurement Objects	Temp. [°C]	Emiss.	Refl. temp. [°C]	Remarks
Hot spot 1	28.0	0.93	19.0	Temperature recorded at R-phase
Hot spot 2	29.3	0.93	19.0	Temperature recorded at Y-phas
Hot spot 3	39.3	0.93	19.0	Temperature recorded at B-phase

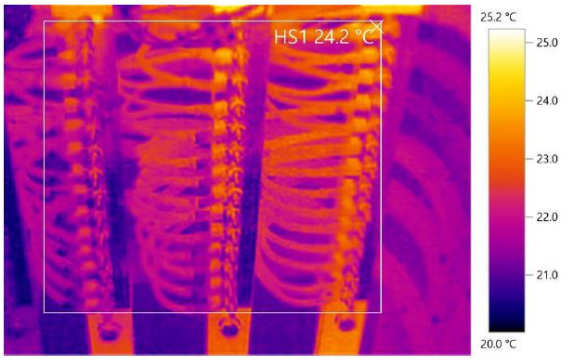
Main panel Bus-Bar chamber:

Measurement Objects	Temp. [°C]	Emiss.	Refl. temp. [°C]	Remarks
Hot spot 1	24.2	0.93	19.0	Temperature recorded at the terminations

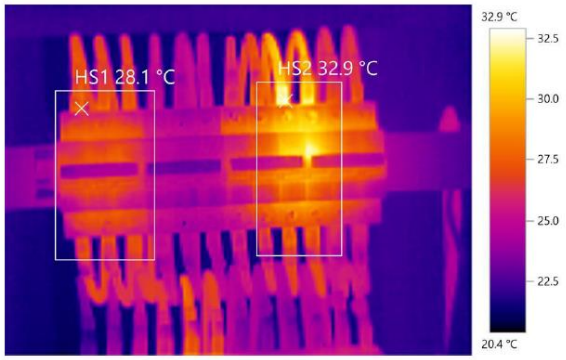
Outgoing MCB feeders:

Measurement Objects	Temp. [°C]	Emiss.	Refl. temp. [°C]	Remarks
Hot spot 1	28.1	0.93	19.0	Temperatutre recorded at MCB
Hot spot 2	32.9	0.93	19.0	Temperatutre recorded at MCB

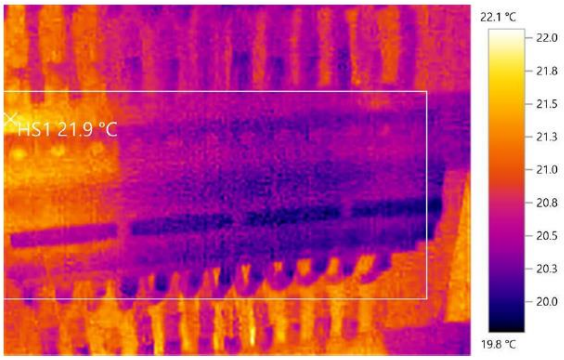
Outgoing MCB feeders:

Measurement Objects	Temp. [°C]	Emiss.	Refl. temp. [°C]	Remarks
Hot spot 1	21.9	0.93	19.0	Temperature recorded at MCB's

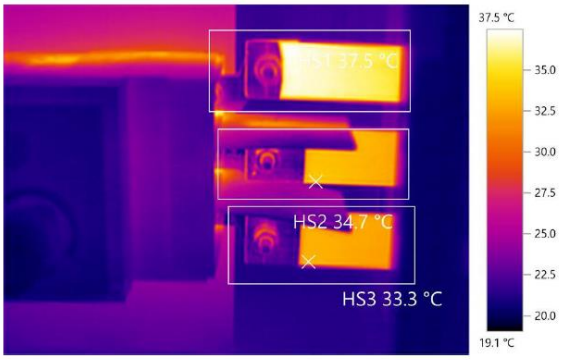
AC panel Outgoing MCCB Feeder:

Measurement Objects	Temp. [°C]	Emiss.	Refl. temp. [°C]	Remarks
Hot spot 1	37.5	0.93	19.0	Temperature recorded at R-phase
Hot spot 2	34.7	0.93	19.0	Temperature recorded at Y-phas
Hot spot 3	33.3	0.93	19.0	Temperature recorded at B-phase

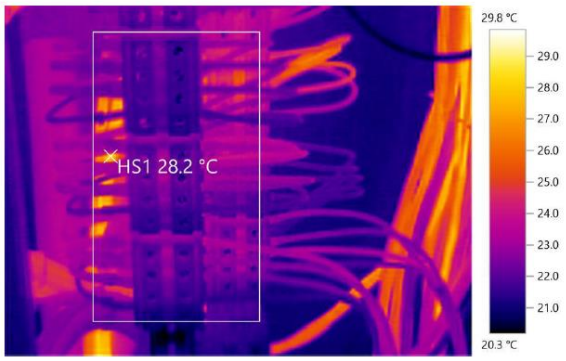
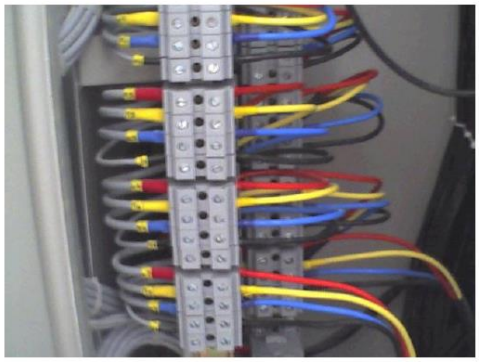
Cable Chamber:

Measurement Objects	Temp. [°C]	Emiss.	Refl. temp. [°C]	Remarks
Hot spot 1	28.2	0.93	19.0	Maximum Temperature area

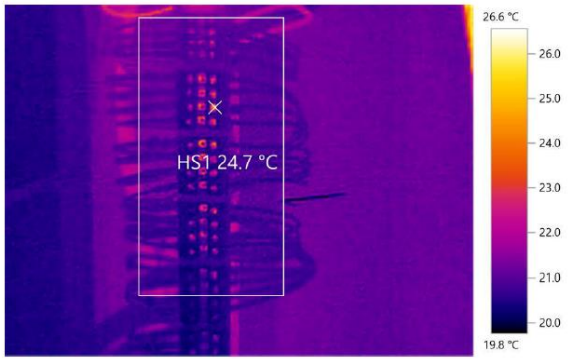
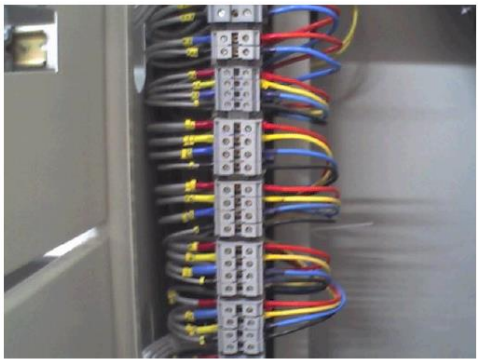
Cable chamber:

Measurement Objects	Temp. [°C]	Emiss.	Refl. temp. [°C]	Remarks
Hot spot 1	24.7	0.93	19.0	Maximum Temperature area

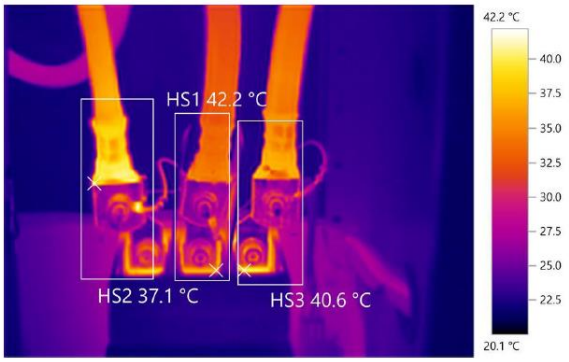
AC Panel Main incomer:

Measurement Objects	Temp. [°C]	Emiss.	Refl. temp. [°C]	Remarks
Hot spot 1	42.2	0.93	19.0	Temperature recorded at R-phase
Hot spot 2	37.1	0.93	19.0	Temperature recorded at Y-phas
Hot spot 3	40.6	0.93	19.0	Temperature recorded at B-phase

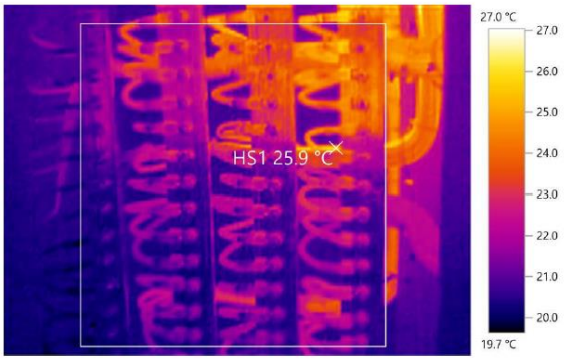
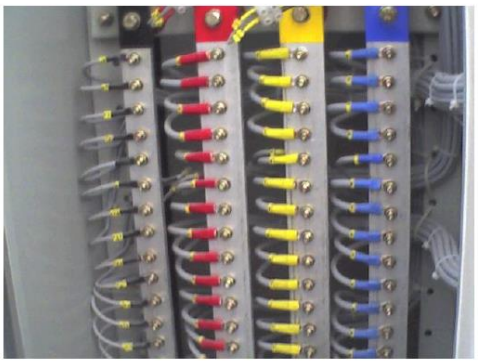
AC panel Bus-Bar chamber:

Measurement Objects	Temp. [°C]	Emiss.	Refl. temp. [°C]	Remarks
Hot spot 1	25.9	0.93	19.0	Temperature recorded at terminations

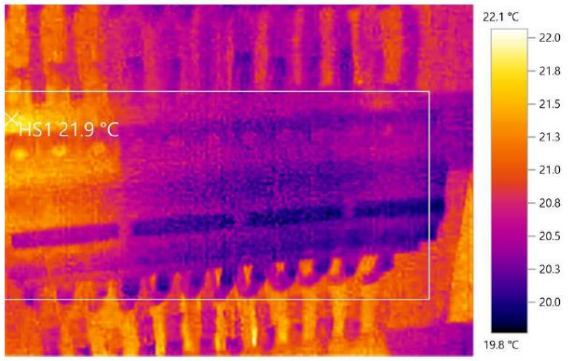
AC Panel outgoing Feeders:

Measurement Objects	Temp. [°C]	Emiss.	Refl. temp. [°C]	Remarks
Hot spot 1	21.9	0.93	19.0	Temperature recorded at MCB's

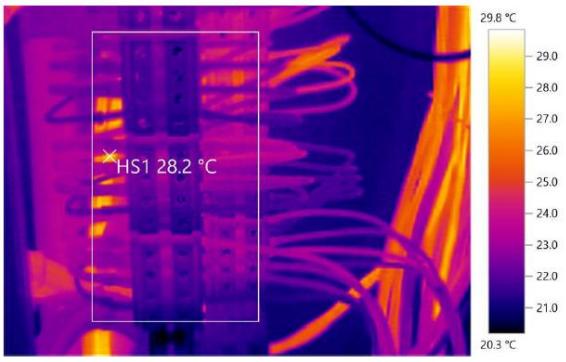
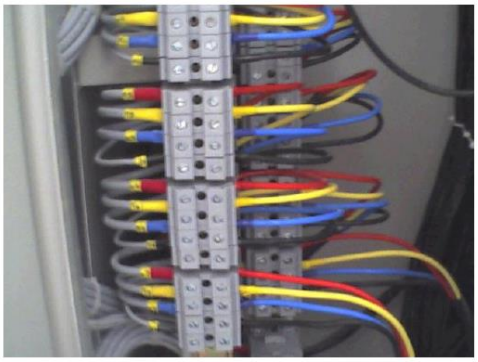
AC Panel outgoing cable chamber:

Measurement Objects	Temp. [°C]	Emiss.	Refl. temp. [°C]	Remarks
Hot spot 1	28.2	0.93	19.0	Maximum Temperature area

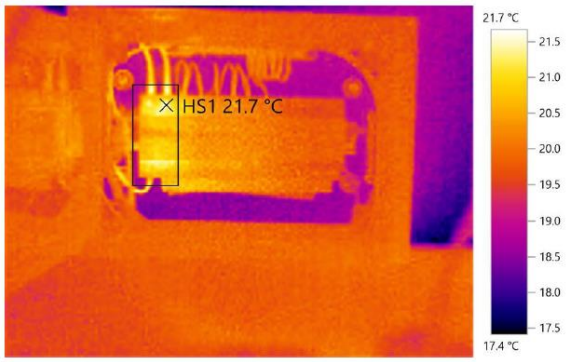
UPS DB:

Measurement Objects	Temp. [°C]	Emiss.	Refl. temp. [°C]	Remarks
Hot spot 1	21.7	0.93	19.0	Maximum Temperature area

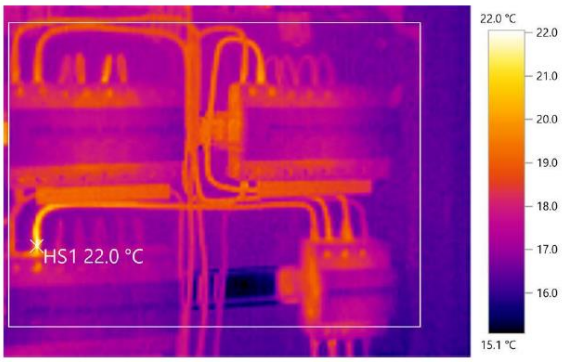
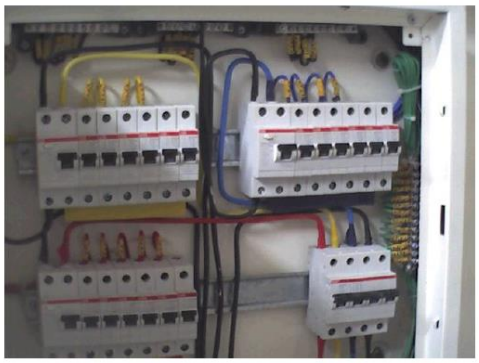
Admin building Ground floor DB:

Measurement Objects	Temp. [°C]	Emiss.	Refl. temp. [°C]	Remarks
Hot spot 1	22.0	0.93	19.0	Maximum Temperature area

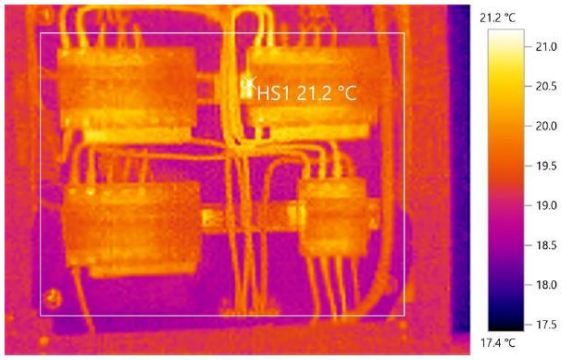
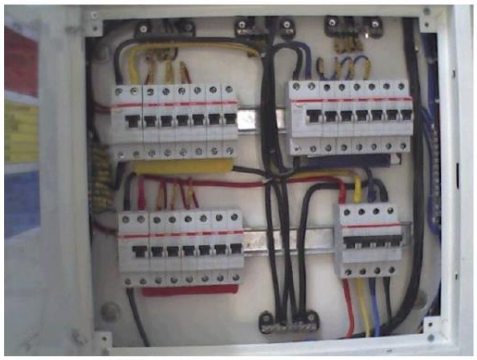
Academic Building Second floor DB:

Measurement Objects	Temp. [°C]	Emiss.	Refl. temp. [°C]	Remarks
Hot spot 1	21.2	0.93	19.0	Maximum Temperature area

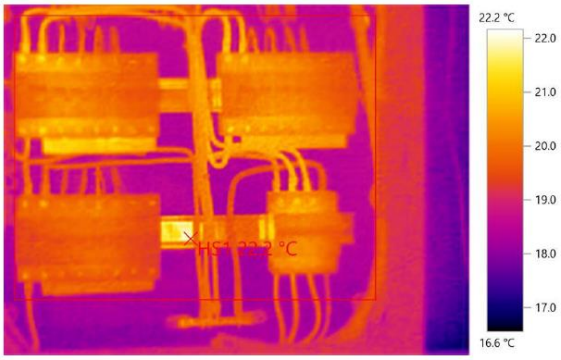
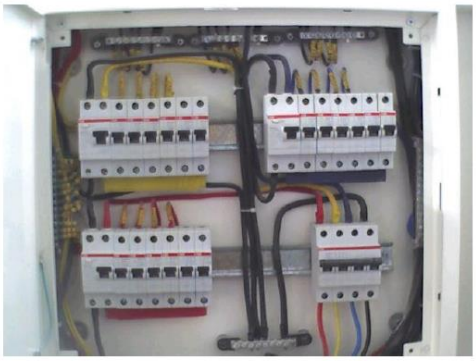
Admin building First Floor PDB:

Measurement Objects	Temp. [°C]	Emiss.	Refl. temp. [°C]	Remarks
Hot spot 1	22.2	0.93	19.0	Maximum temperature area
